Coal Mine Fatal Accident 2004-01

Operator:	Canyon Fuel Company, LLC
Mine:	SUFCO Mine
Accident Date:	January 3, 2004
Classification:	Machinery
Location:	District 9, Salina, UT
Mine Type:	Underground
Employment:	281
Production	28,500 tons/day

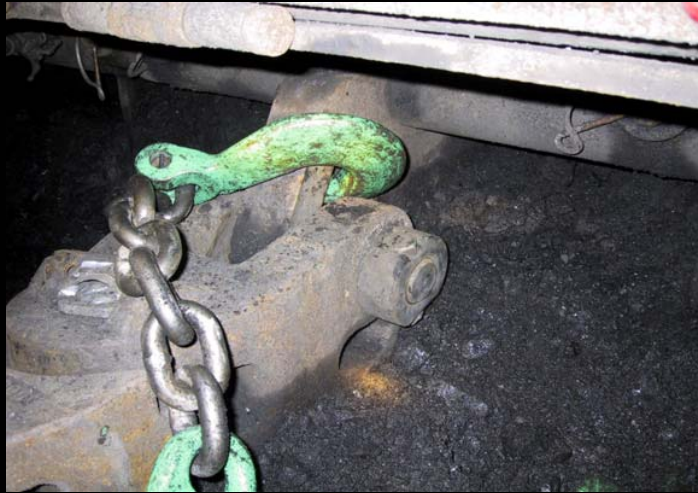
- Two of the slings were used to connect from the base of No. 49 shield to the face conveyor.
- They planned to tension the sling rigging by pushing the face conveyor forward with the adjacent shields.
- At the same time, the double-acting ram shield advance on No. 49 shield would be used to pull that shield forward. This would also reduce the tension applied to the chain slings as the adjacent shields pushed the face conveyor forward.

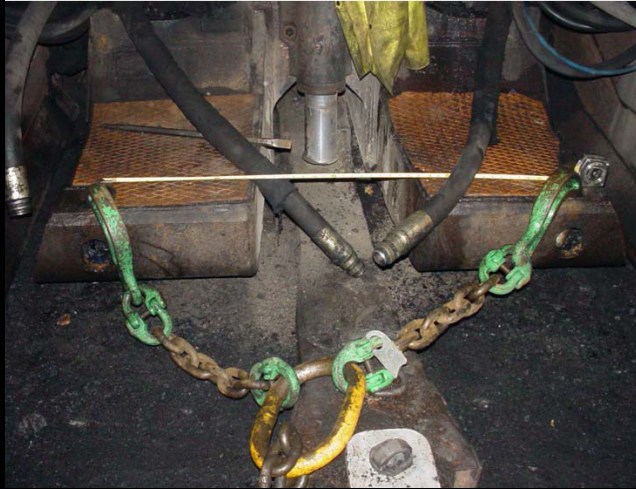
- The shearer operator stood on the base skid of No. 49 shield to operate the manual valves to advance the shield.
- The CM Section Foreman was at No. 48 shield and a diesel mechanic was at No. 50 shield to operate the conveyor advance functions of those shields.
- Several moments passed as the miners attempted to free No. 49 shield using this. Several of the miners heard a “pinging” noise, which they thought was coming from the chain rigging.

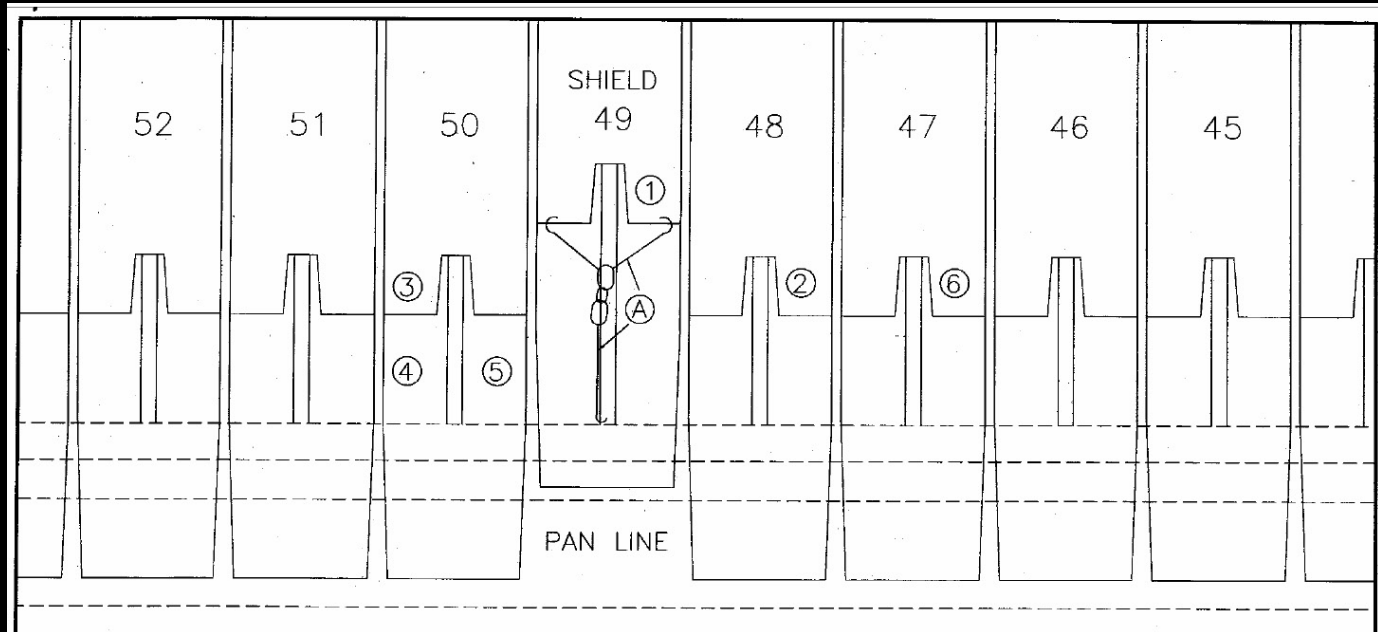
① Shearer Operator (Victim)

③ Diesel Mechanic

⑤ Laborer

② CM Foreman

④ Mechanic

⑥ Longwall Coordinator

Ⓐ Chain rigging between shield & face conveyor

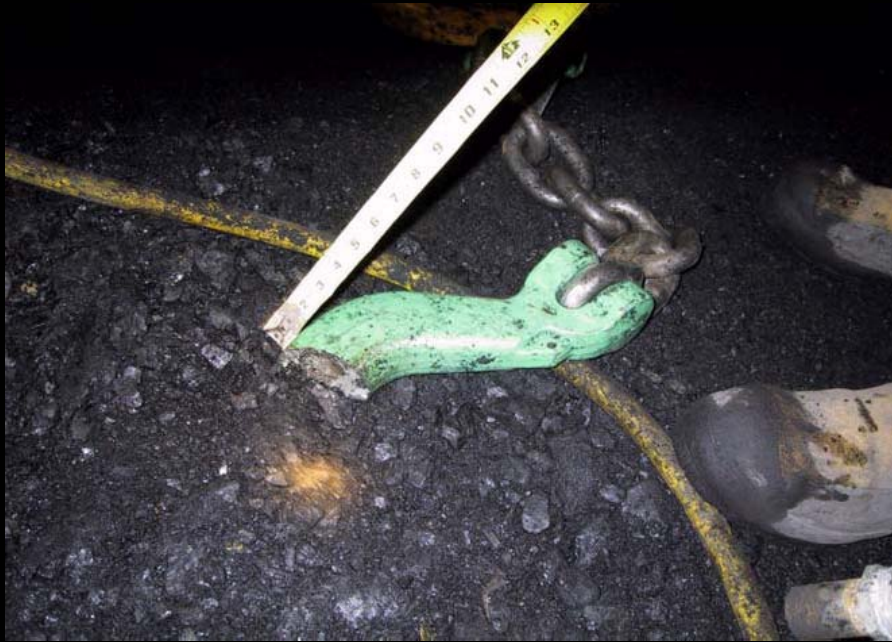
- As the last attempt was made, the hook on the chain sling attached to the face conveyor broke.
- The remaining portion of the hook that was still attached to the chain recoiled, striking the shearer operator in the left side of the face and head, causing fatal injuries.

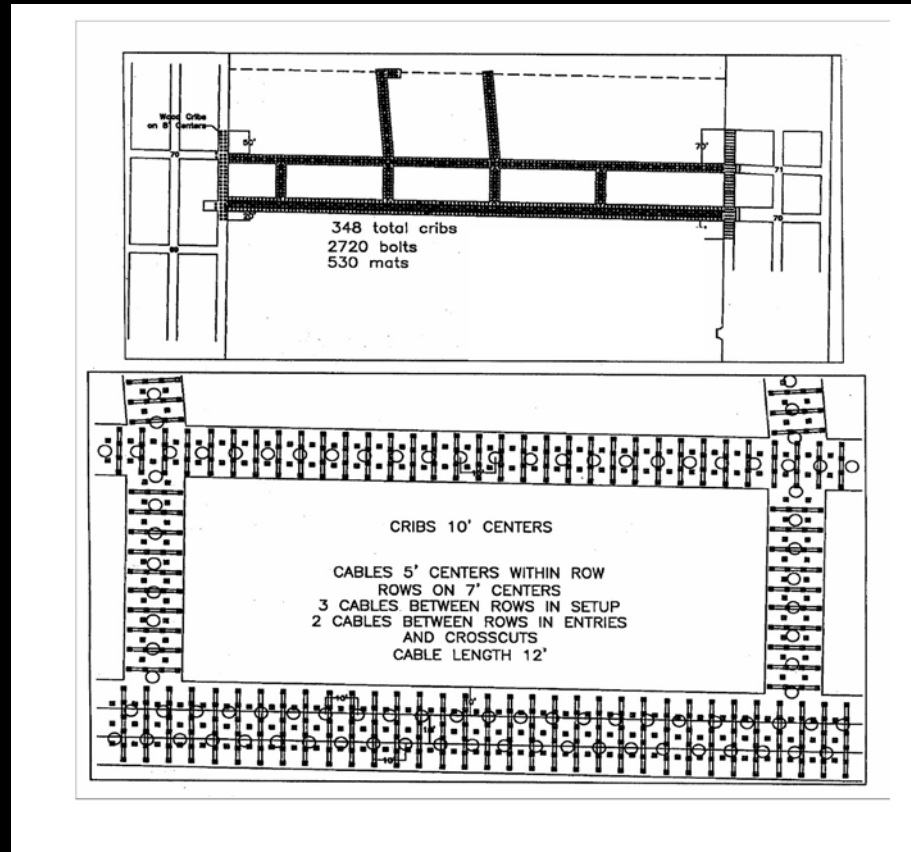
- To mine through the setup rooms, additional support was installed prior to the longwall retreating through the area.

- The longwall retreated through the recovery chutes, inby bleeder entry, and connecting crosscuts with little to no trouble.
- As the longwall entered the setup entry, a significant number of the 4' diameter cuttable cribs failed prematurely, well below the design strength of 1800 tons, causing convergence of the entry and yielding of the shield supports.
- By January 1, 2004, production ceased due to shields being "iron bound."
- By January 3, ~24 shields were "iron bound", and 27 others were deemed "critical", with less than 6" travel remaining on the legs.

Causal Factor: The failure of the poured-type concrete cribs once the longwall entered the setup entry caused significant convergence of the entry, thus creating tremendous loading on the Joy Mining Machinery 2 x 970 UST supports and causing a yield condition of the supports and subsequent “iron bound” condition.

Corrective Actions: Re-evaluate the mine's roof control needs in the future and further evaluate the logistics and practice of longwall retreat mining through previously developed entries. In addition, should future use of poured-type concrete cribs be used in a similar situation, testing of the product should be conducted to verify proper mix and that desired strength has been achieved.

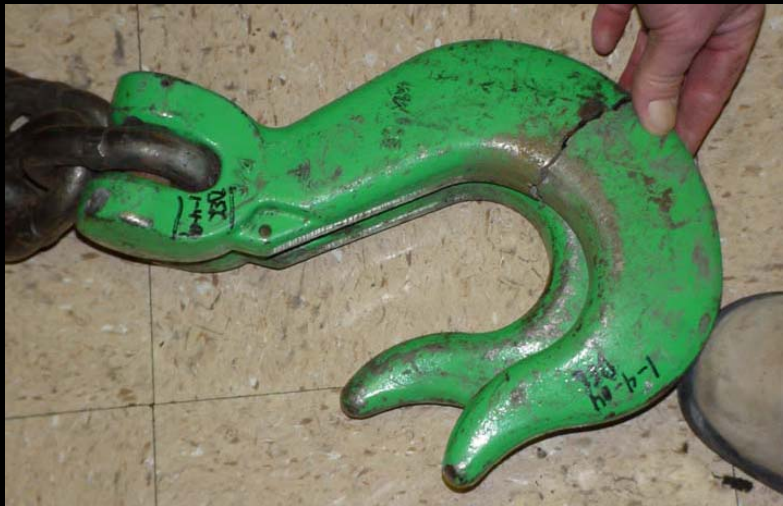
- The centerline of the hook should have been in line with the centerline of the chain. However, wear marks showed that there was an angle of $\sim 60^\circ$ between the centerline of the hook and the centerline of the chain.
- This misalignment caused the inside dimension of the hook to spread from approximately $2\frac{1}{2}$ " to about $4\frac{1}{8}$ " before it broke (photo below).
- The hook would not properly engage due to the physical characteristics of the hook and the size and bore of the welded ear on the conveyor, thus causing tip loading of the hook, reducing the working load by 41% (actual working load: 14,473 lbs; actual breaking load: 57,892 lbs).

The force applied by the two adjacent shields during conveyor advance loading to the face conveyor and to the chain sling was 127,840 lbs when the No. 49 shield was not assisting in the process (2.2 x breaking load).

Causal Factor: Incorrect rigging and subsequent failure of the two-legged sling between the longwall shield and the face conveyor.

The direct cause of the accident was the use of the two-legged chain slings in an application where the applied loads exceeded the design strength of the slings and the improper placement of the hook in the slotted hole on the face conveyor which caused tip loading. The hook was not properly engaged in the elongated slot on the conveyor, and could not be, due to the physical characteristics of the hook and slot. These factors resulted in the hook breaking, recoiling, and causing the accident during the attempt to advance No. 49 shield. In addition, the position of the victim on the toe of No. 49 shield, in the "direct line of fire" of the tensioned chain sling, put him in a hazardous location. The failure of management to take corrective actions when a hazardous work practice was observed was a contributing factor to the cause of the accident.

Corrective Actions: Following the January 3, 2004 accident, SUFCO management removed all chain slings from service, used other means to free the “iron bound” shields, and conducted training classes regarding chain slings and the rigging process. SUFCO management should have taken a more proactive approach to the initial sling failure that occurred prior to the accident on the section and made all persons aware of that failure. Both the longwall coordinator and the foreman in charge of the work at No. 49 shield had safety concerns with the chain sling rigging that was being used. Management should strictly enforce safe work procedures for proper use of rigging and safe positioning of miners when doing this type of work. The operator should proactively ensure that proper procedures are followed through job observations, task risk analysis, or equivalent means .

- Ensure that chain assemblies (rigging) are rated for the loads being pulled. Consult the chain manufacturer to determine chain assembly rated capacities and also required de-ratings due to the geometry of the final rigging arrangement.
- Ensure persons are positioned in a safe location before tension is applied when dragging or towing equipment with chains, wire rope, or any other rigging.
- Ensure that chains and hooks are properly attached or rigged.
- Evaluate pillar strength and design before second mining areas containing unusual circumstances, such as setup rooms.
